COLORS OF WAR

WE DELVE DEEPLY INTO THE CHALLENGE ARCHIVES TO PRESENT MORE COLOR IMAGES OF WWII AIRCRAFT IN ACTION BY MICHAEL O'LEARY

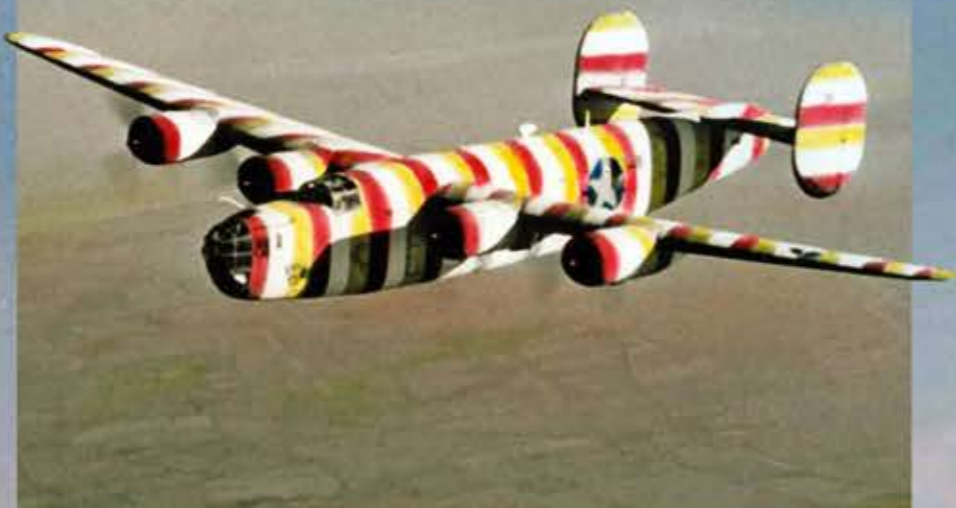
The subject of "Formation Ships" deserves a book of its own. Formation flying as the bombers gathered for their missions into Occupied Europe was a very serious business and, sadly, mid-air collisions often took place. The weather was usually not great and poor visibility made it hard to spot the other bombers. To get around this, "Formation Ships" or "Lead Assembly Ships" were created. Sometimes these were time-expired bombers, sometimes not, but they all had one thing in common — wild and fanciful paint schemes. The aircraft also often had a variety of lights added for extra visibility for the pilots trying to form on them. This B-24D Liberator, USAAF 41-23667, has had all its armament removed and was assigned to the 328th Bomb Squadron, 93rd Bomb Group, at RAF Hardwick. The wild paint scheme made the aircraft easy to spot and it carried the name *Barber Bob*.

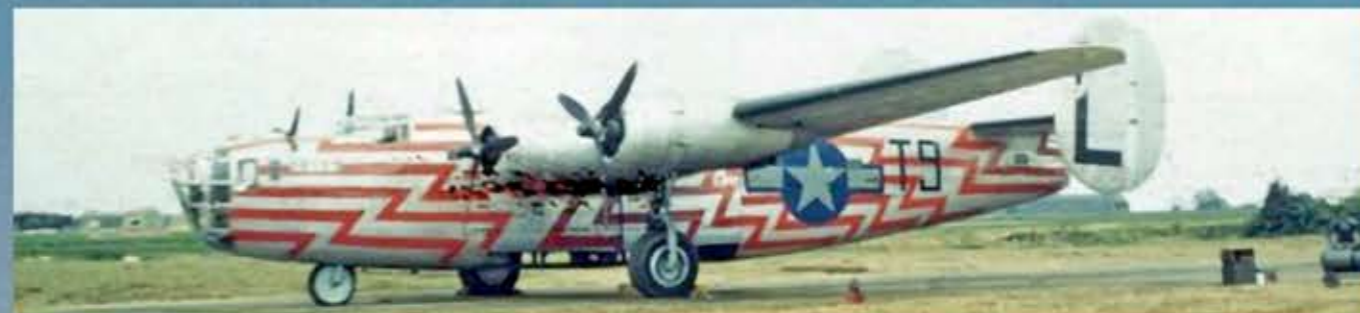
B-24D USAAF 41-24109 *Silver Streak* was the assembly ship for the 466th Bombardment Group based at RAF Attlebridge. Previously named *Ready & Willing*, the bomber had flown on the Ploesti mission with the 93rd Bomb Group and returned safely to Benghazi, Libya, on 1 August 1943. Flown to Britain, it was declared War Weary and made into an assembly ship.
