AVOIDABLE DISASTER

THE NATIONAL TRANSPORTATION AND SAFETY BOARD HAS RELEASED ITS REPORT ON THE TRAGIC MID-AIR COLLISION BETWEEN THE COMMEMORATIVE AIR FORCE'S FLYING FORTRESSS AND KINGCOBRA
REPORT AND PHOTOGRAPHY VIA THE NTSB

EDITOR'S NOTE: During December 2024, the NTSB released its report on the deadly collision between the CAF's B-17G and P-63F — an accident that claimed the lives of five fine men and the destruction of two historically significant aircraft. To many of us that are long-time airshow attendees, the causes of the accident were pretty obvious from the beginning but we wanted to wait on the results of the final report before making any comments. In fact, we are not going to make any comments but will let the report stand by itself. There is a certain element that will accuse *Air Classics* of being sensationalist or insensitive by printing the report and photographs. However, and as we have stated numerous times in the past, to learn by our mistakes we must view our mistakes. The NTSB report leaves a lot to think about and its conclusions will hopefully change the airshow world for the better. As usual, we welcome reader comments at moleary2challenge@gmail.com.

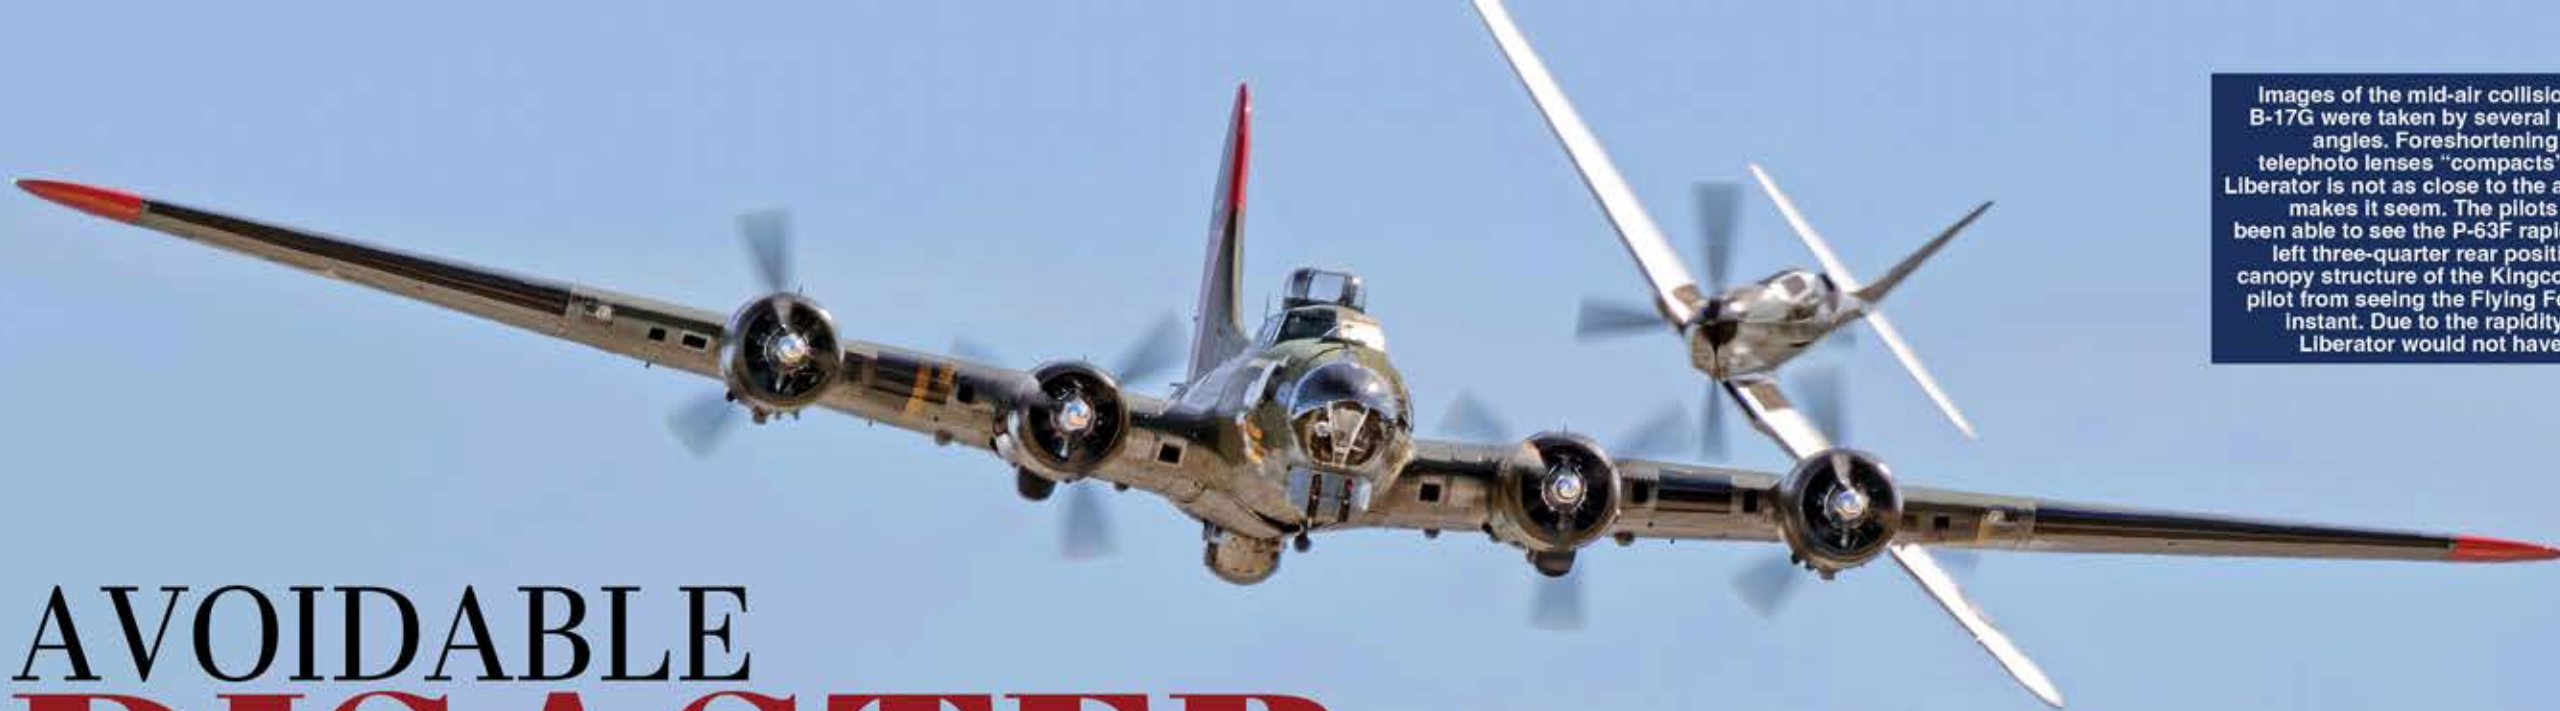
Images of the mid-air collision between the P-63F and the B-17G were taken by several photographers from different angles. Foreshortening of the subjects by the use of telephoto lenses "compacts" the images. In this shot, the Liberator is not as close to the accident aircraft as the image makes it seem. The pilots of the B-17G would not have been able to see the P-63F rapidly overtaking them from the left three-quarter rear position. Also, the bank angle and canopy structure of the Kingcobra would have blocked that pilot from seeing the Flying Fortress until the last possible instant. Due to the rapidity of the event, the crew of the Liberator would not have had time to radio a warning.

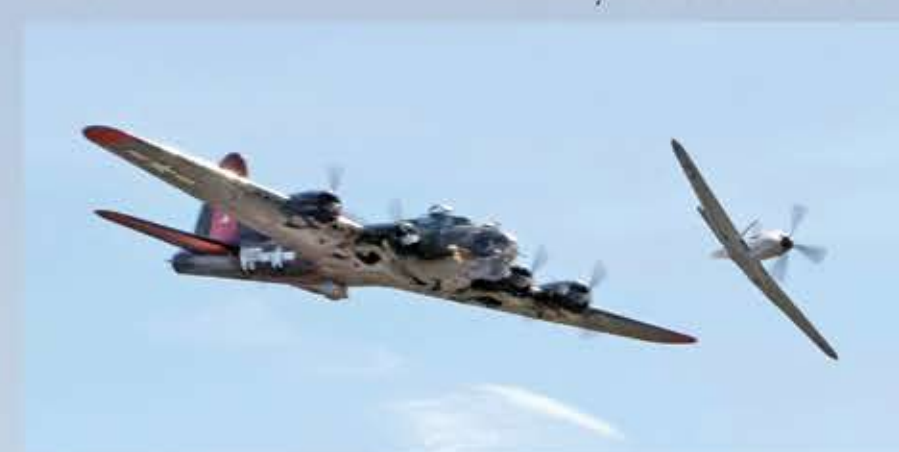
This view, taken from the B-17G's right side, makes it seem that the P-63F has passed the Flying Fortress. However, this is once again foreshortening due to the use of a long telephoto lens. The P-63F is actually heading to the left rear fuselage behind the wing's trailing edge and in front of the left horizontal stabilizer. What the photo does show, however, is that the pilot of the P-63F does not have visual contact with the bomber.
