# KEEPING THE AIRACOBRAS FLYING

A CREW CHIEF FROM THE 1st AND 31st PURSUIT GROUPS REFLECTS ON THE AMOUNT OF WORK IT TOOK TO KEEP THE NEW BELL P-39 OPERATIONAL  
 BY RAYMOND J. TELICZAN, SR. (LT. COL. USAF, RET.)

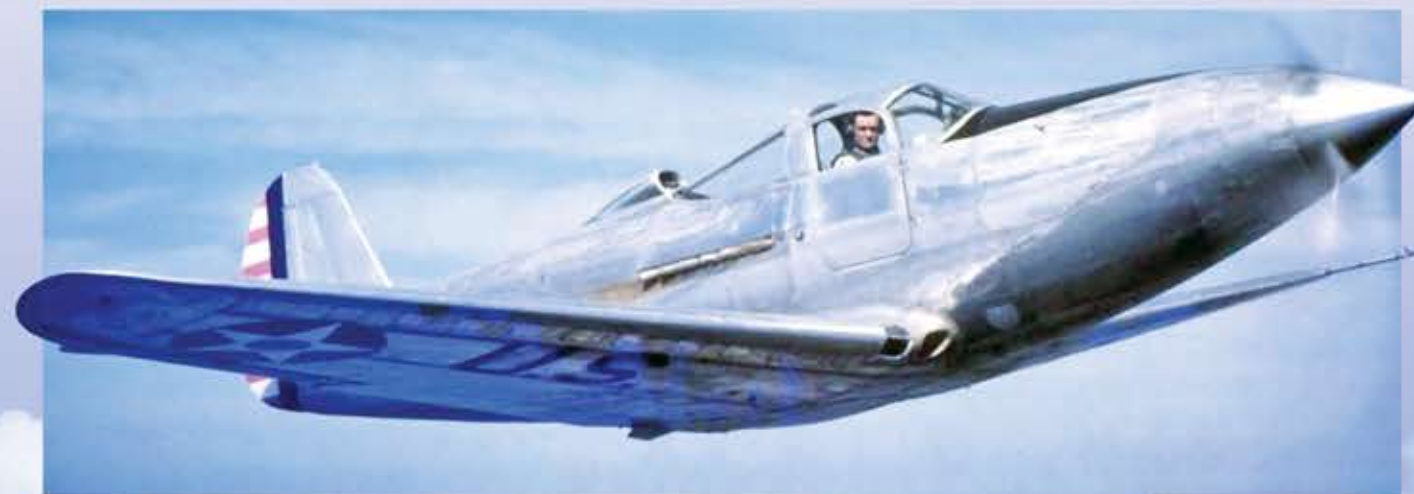
As noted in the story, the prototype Airacobras were things of beauty in gleaming polished aluminum and even looked like they were going fast when sitting still. In this photograph, Bell test pilot Jack Woolams has rolled down the right window in the auto-style entry door while he flies close formation on the camera plane.

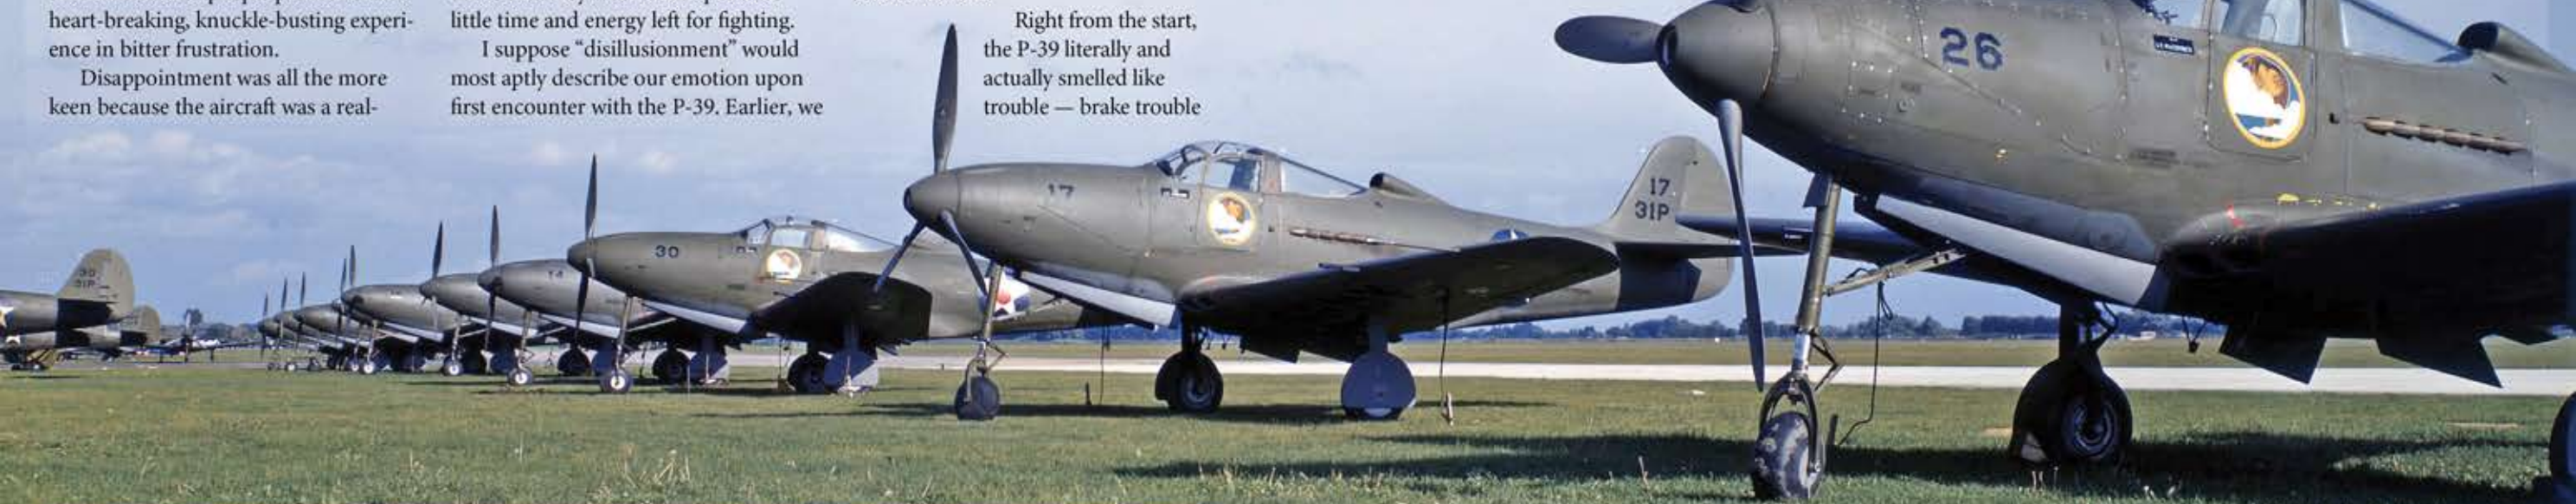
Dramatic view of P-39D Airacobras assigned to the 31st Pursuit Group (39th, 40th, 41st Pursuit Squadrons) at Selfridge Field. As war drew closer, the markings began to be toned down. For example, the individual aircraft numbers and the group number had been painted in yellow but this changed to black (compare with the "Contents" page image in the August 2024 issue). The "car doors" were ideal places on which to paint the unit insignia.
